TRANSPORTATION TECHNOLOGY CENTER, INC.

Research Motivation

Rail Defects

Rail Flaw Inspection

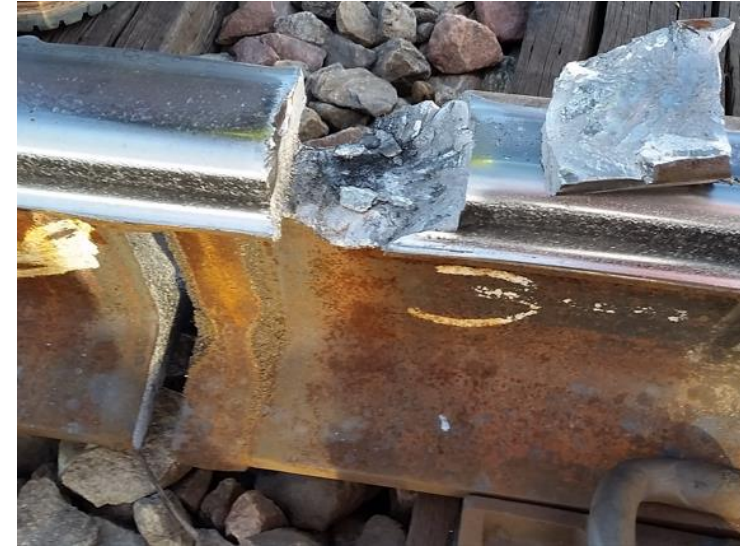
Example of a Rail Failure

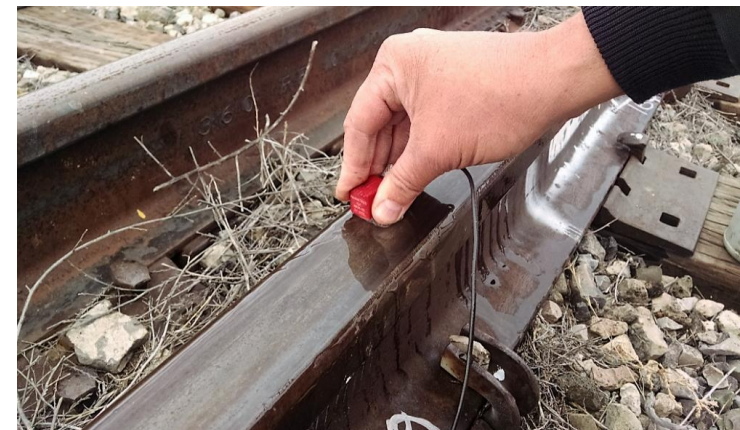
Hand-held Ultrasound Testing

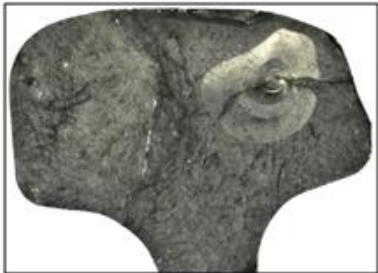
Transverse fissure (TF)

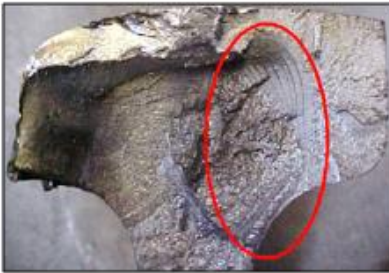
Compound Fissure (CF)

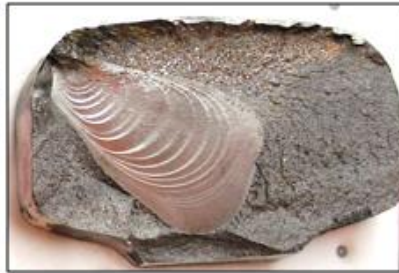
Detail Fracture (DF)

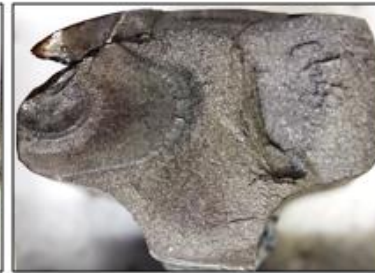
DF under Shelling

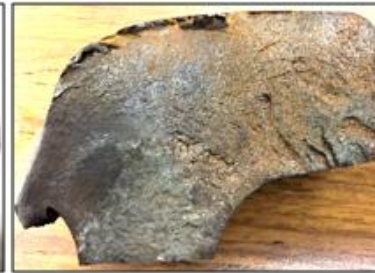
Reverse DF

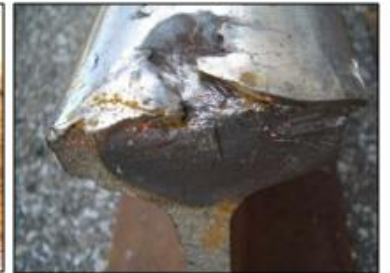
Engine Burn Fracture

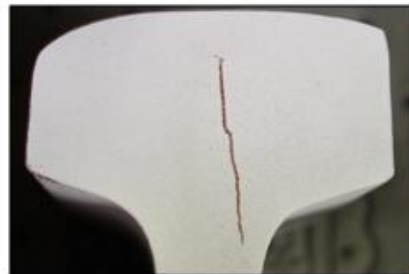
Vertical Split Head (VSH)

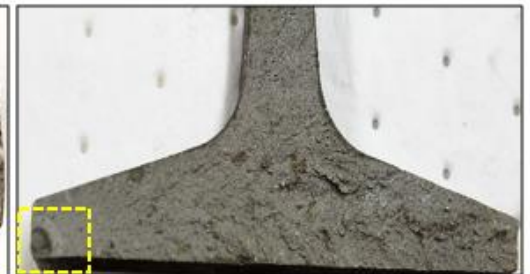
Base Defect

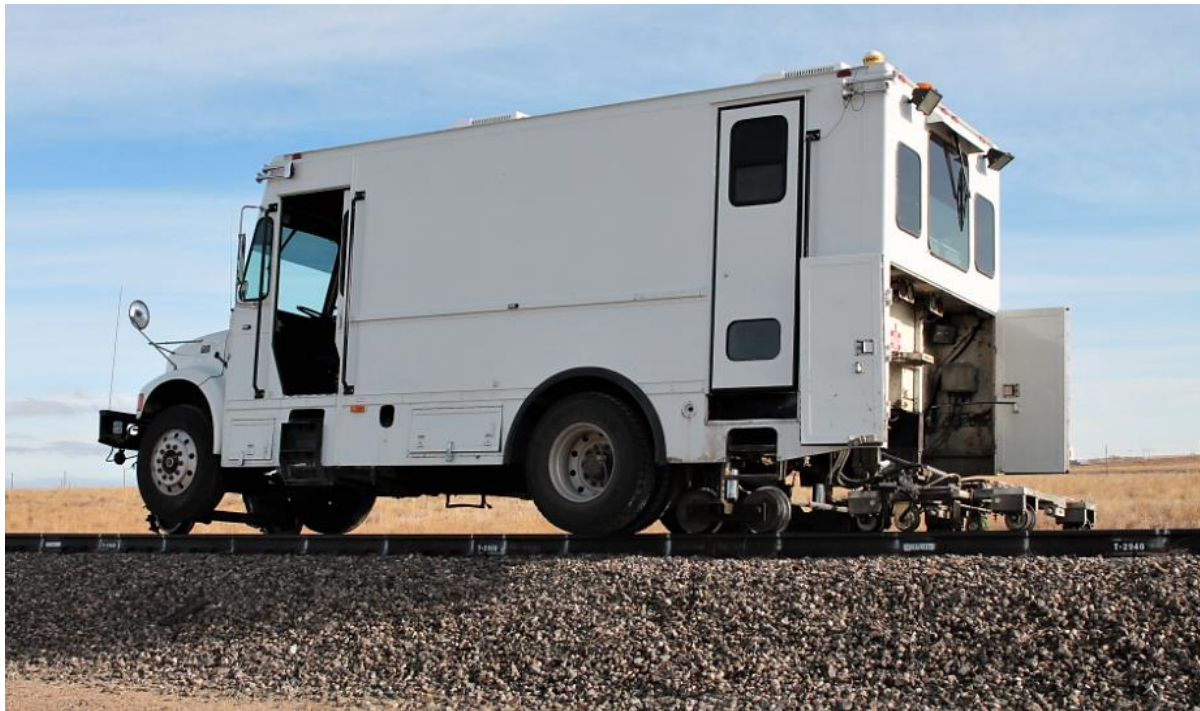
Rail Detector Car

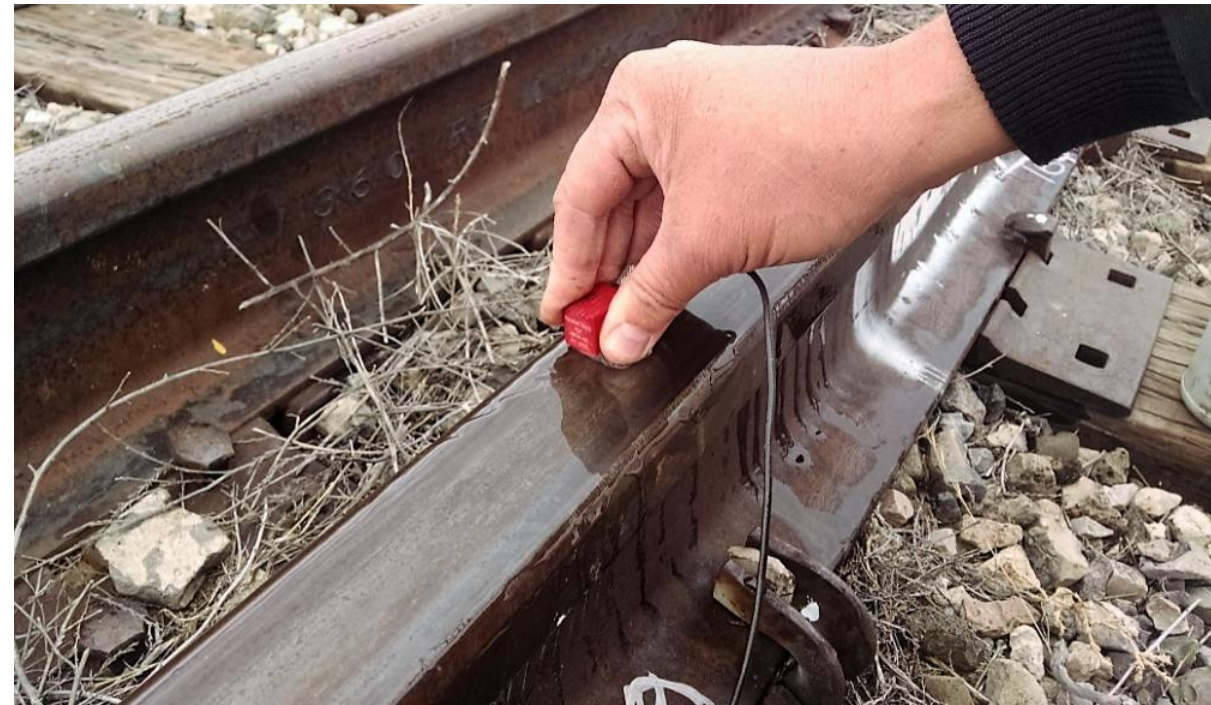
Hand-held UT

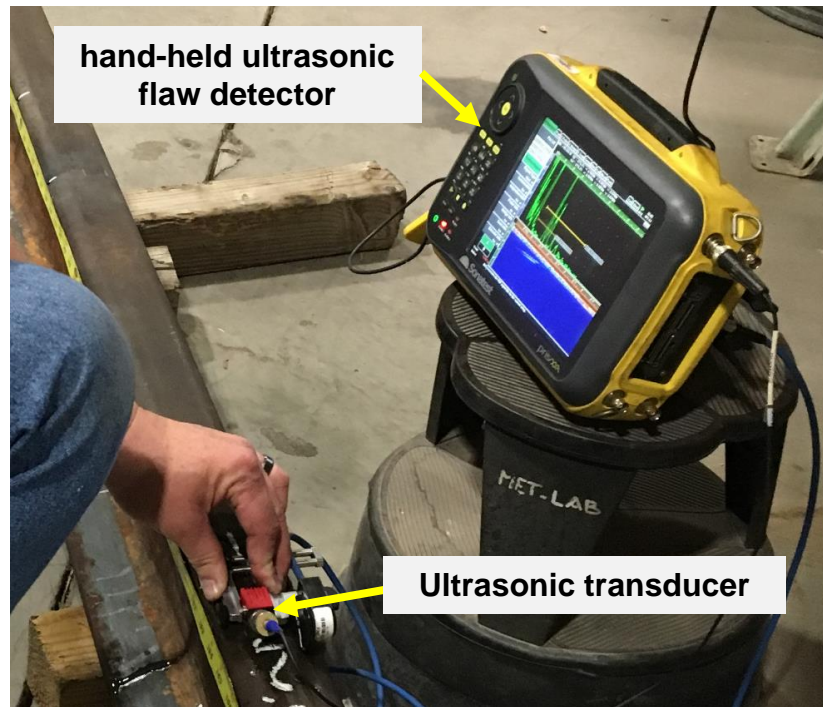
Portable hand-held ultrasonic
flaw detector

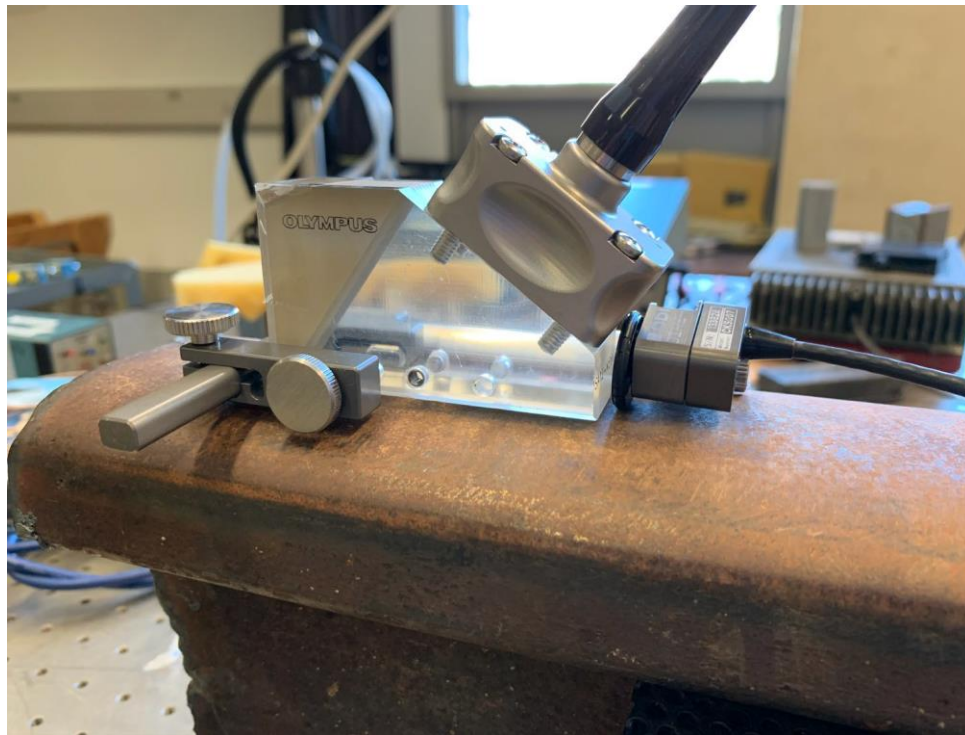
- **GOAL - Develop field deployable robust rail flaw imaging prototype**
 - 3-D image reconstruction from 2-D slices using sparse SAFT with sub-array transmission

UCSD rail flaw imaging setup
